# Manhole Inspection Summary

# Manhole # S37S\_\_049MH

Insp Date: **1/25/08 9:14 AM**

**Location** Address: **henry st**

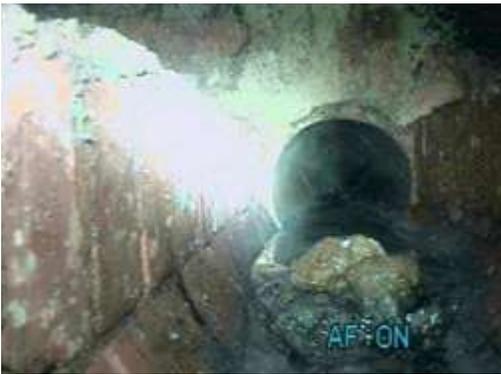
Misc

channel debris

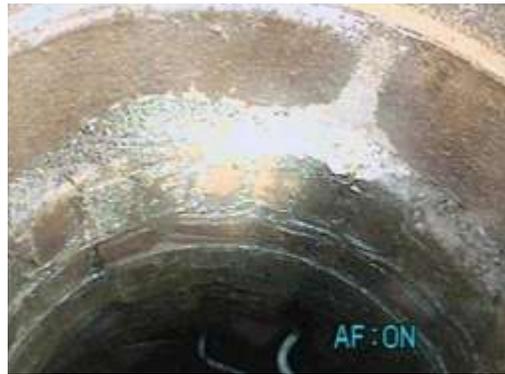
Defect 2

**Frame** Offset: **1** (in.)

offset

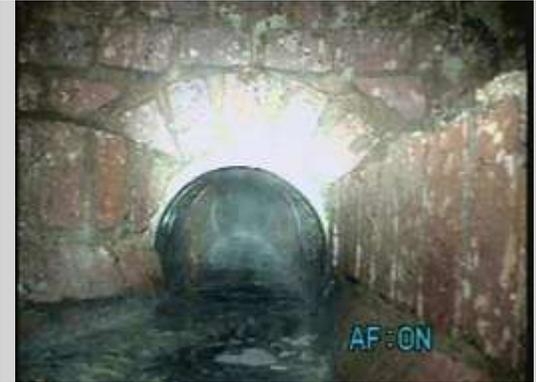
12 O'Clock Outflow

8 in. Circular Gravity Sewer  
Pipe Out @ 12 O'Clock

Pipe Height: **0** (in.) Direct  
Pipe Material: **Clay**  Pipe Lined  
Invert Depth: **9.00** (ft.) Flow Characteristics: **Fast**  
Deposits:  None  Mud  Sludge  Debris  Grease  
Silt Depth: **0** (in.) Deposits Extent:  
Infiltration: **None** Pipe Seal Cond: **Unknown**

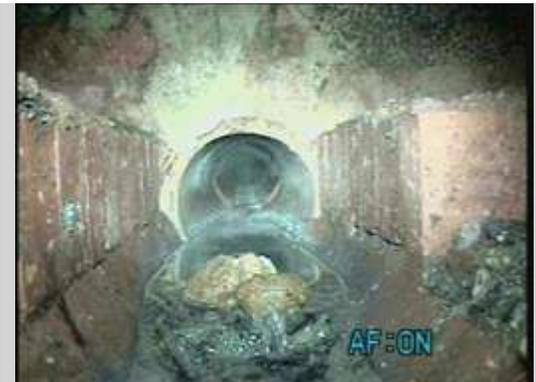
6 O'Clock Inflow

8 in. Circular Gravity Sewer  
Pipe In @ 6 O'Clock

Pipe Height: **0** (in.) Direct  
Pipe Material: **Clay**  Pipe Lined  
Invert Depth: **8.80** (ft.) Flow Characteristics: **Slow**  
Deposits:  None  Mud  Sludge  Debris  Grease  
Silt Depth: **0** (in.) Deposits Extent:  
Infiltration: **None** Pipe Seal Cond: **Unknown**

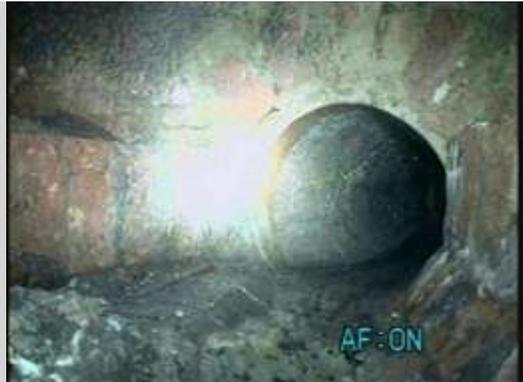
9 O'Clock Inflow

8 in. Circular Gravity Sewer

Pipe In @ 9 O'Clock
